Property Inspection Report

Richard Fitzwater TREC# 8317 FYI Property Inspection

1234 Main St Inspection Prepared For: First Last Agent: Rose Glasses - Home Buyers Realty

> Date of Inspection: 2/1/2022 Year Built: 2021 Size: 2213 Weather: Sunny

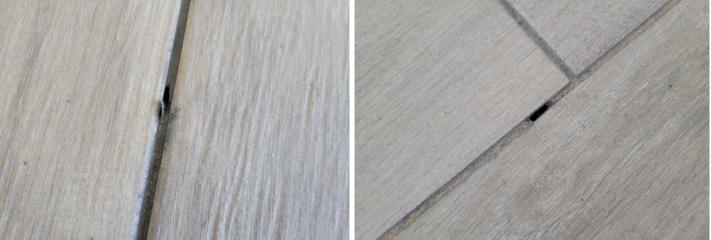
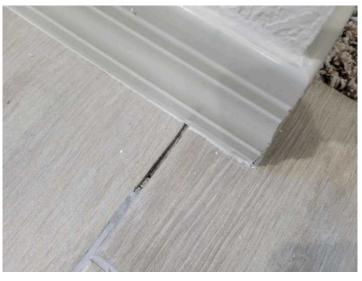
FYI Property Inspe	ction		1234 Main St, El Paso, TX
I=Inspected	NI=Not Inspected	NP=Not Present	D=Deficient
I NI NP D			
	F. Ceilings and Floors		
	Comments:		
	performance and mois	ture penetration.	<i>cies related to structural</i> deficient, not to current standard or
	F.2. Additional tile grou	ut could be added to the	e floor in various locations.
HAMA	Total Contract

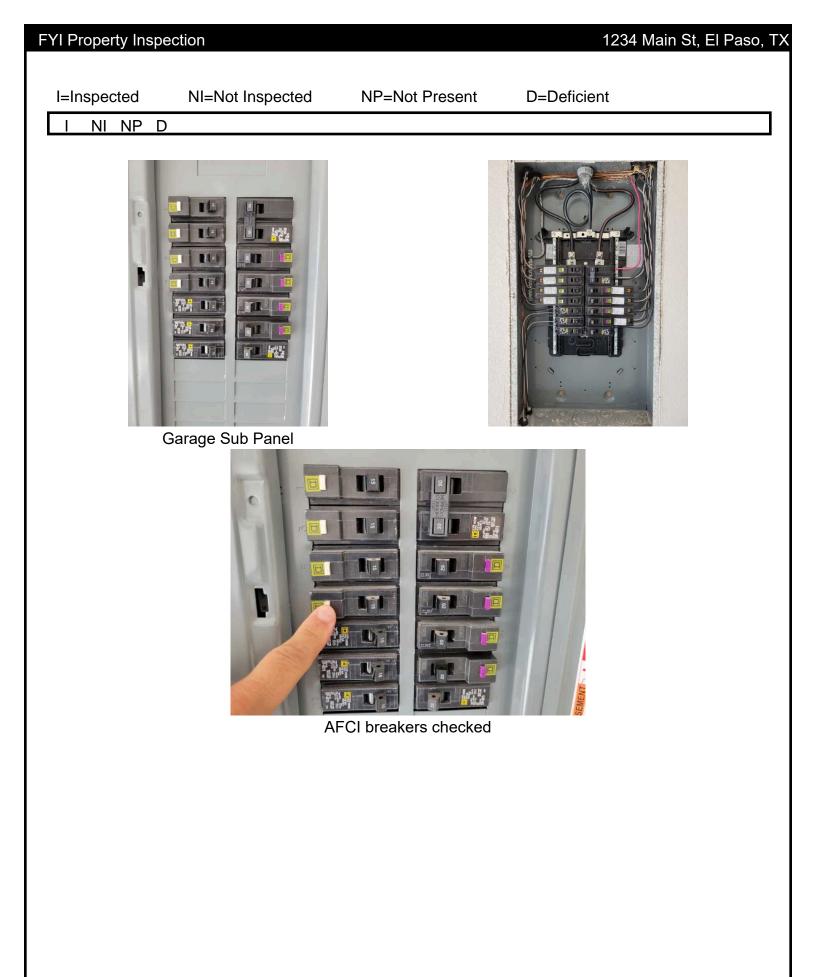
YI Property Inspe	ection		1234 Main St, El Paso,	
I=Inspected	NI=Not Inspected	NP=Not Present	D=Deficient	
I NI NP D				
	11. 6	ELECTRICAL SYSTEMS		
x	A. Service Entrance a	nd Panels		
	Main disconnect was			
	A.1. There is an unde	erground service lateral.		
			it interrupter protection. These s of electrical arcs that can cause	
	A.3. The <u>AFCI</u> circuits inspection. (Using the		d operated properly during the	
	A.4. Disconnect Bran	d: Square D Homeline		
	A.5. Sub panel Brand	: Square D Homeline		
	A.6. See items below that, in my opinion, are deficient, not to current standard or pose a safety threat.			
	A.7. Some breakers v	vere not labeled. (Labels	are not checked for accuracy)	
	A.8. The hole in the s	ub panel should be filled	with a knockout cover.	
Ele	ectrical Main Cut Off		Electrical Main Cut Off

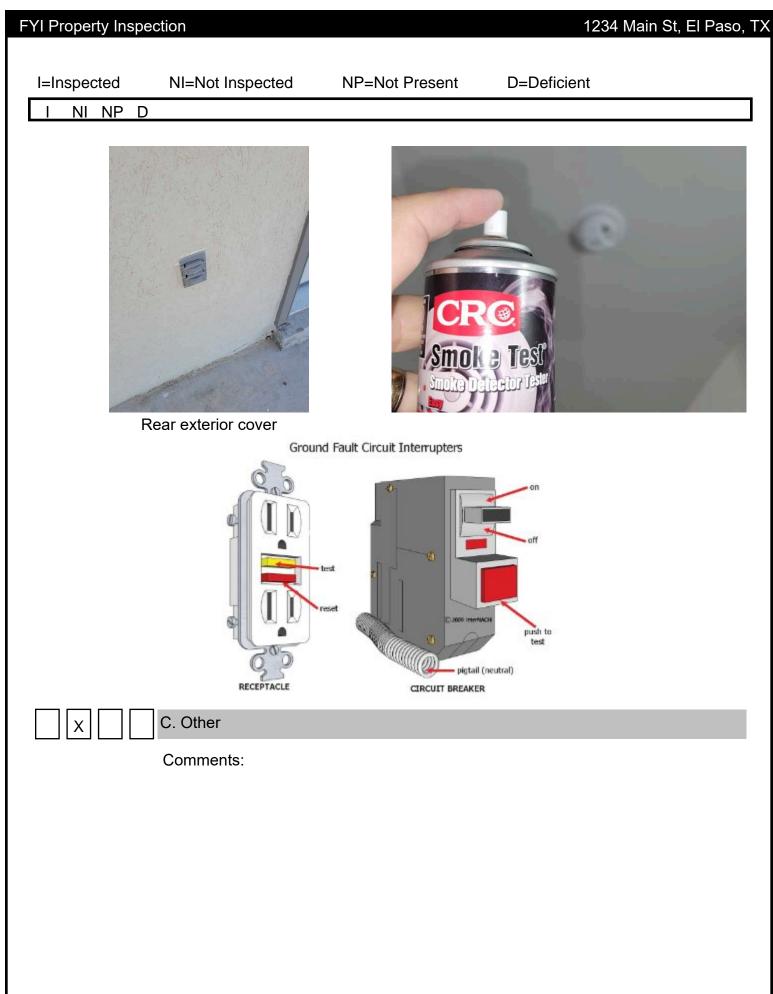
B.7. GFCI reset location for th	e laundry room re	ceptacle(s): in the sub panel.
	B.8. Doorbell operated normal	lly	
			and are functional. Remember to eded according to manufactures
	B.10. See items below that, in pose a safety threat.	my opinion, are d	eficient, not to current standard o
	B.11. The weather resistant ex top to keep water out. Rear ex		cover should have a hinge on the

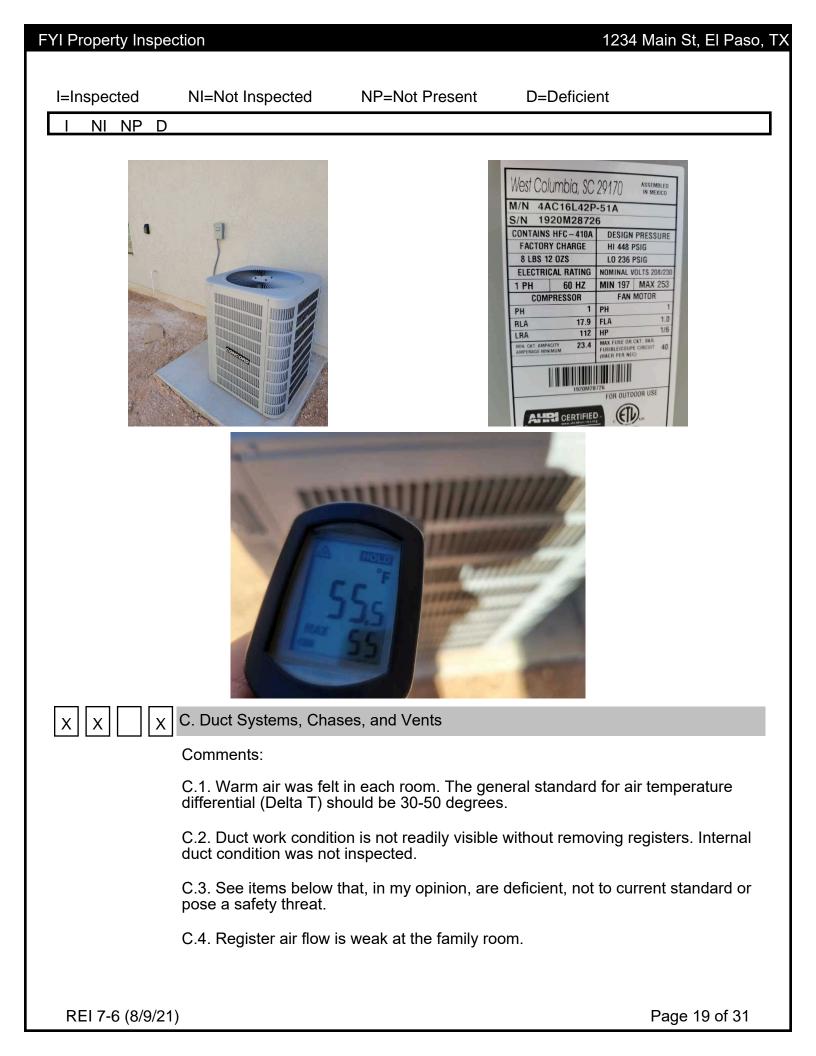
FYI Property Inspection 1234 Main St, El Paso, TX NI=Not Inspected NP=Not Present D=Deficient I=Inspected NI NP D Caulk needed B. Cooling Equipment Х Х Type of Systems: Forced Air- Split system with the condenser on the right side exterior. 3.5 ton unit Comments: B.1. Determining cooling supply adequacy and distribution balance are outside the scope of the home inspection. B.2. System fan and evaporative coils are not readily available for inspection without disassembly. Since we do not disassemble equipment, the condition of the internal parts is unknown. If you are concerned, a licensed HVAC technician can further evaluate the unit. Unit(s) are not pressure tested or checked for leaks, and the setback features on the thermostat controls were not operated. Annual maintenance and service is recommended including changing of filters or pads as needed and lubrication of all parts required. B.3. Cooling Manufacturer was Concord and the estimated manufacture date is 2021. B.4. Air conditioning could not be operated due to outside temperature below 60 degrees. Activating air conditioning during cold weather may cause damage to the system. 45 degrees

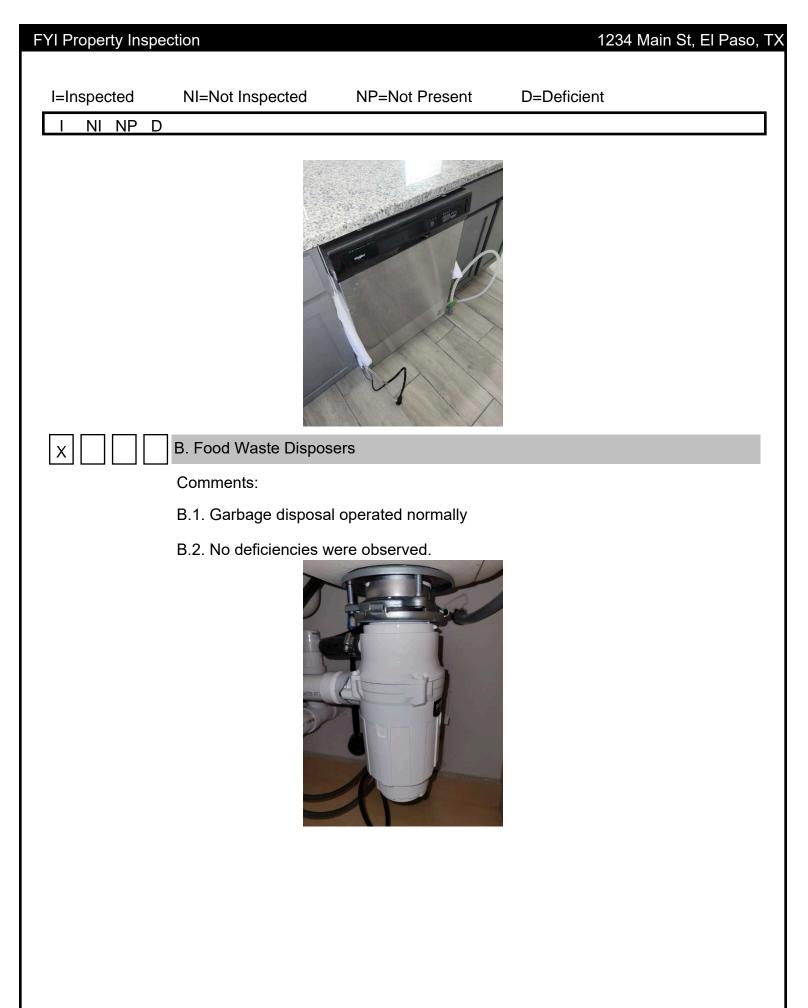
V. APPLIANCES	
	A. Dishwashers		
	Comments:		
	A.1. Installation is incor	mplete. Unable to operat	te.
